Brief Communication: Rapid Assessment of landslide events based on UAV photogrammetry: The 9 January 2021 Cimanggung Landslide, Sumedang, Indonesia

Ali Abdurrahman^{1*}, Muhammad Ariq Budipraja¹, Nur Khoirullah², Faisal Helmi² and Raden Irvan Sophian²

¹Undergraduate Program, Faculty of Geological Engineering, Universitas Padjadjaran

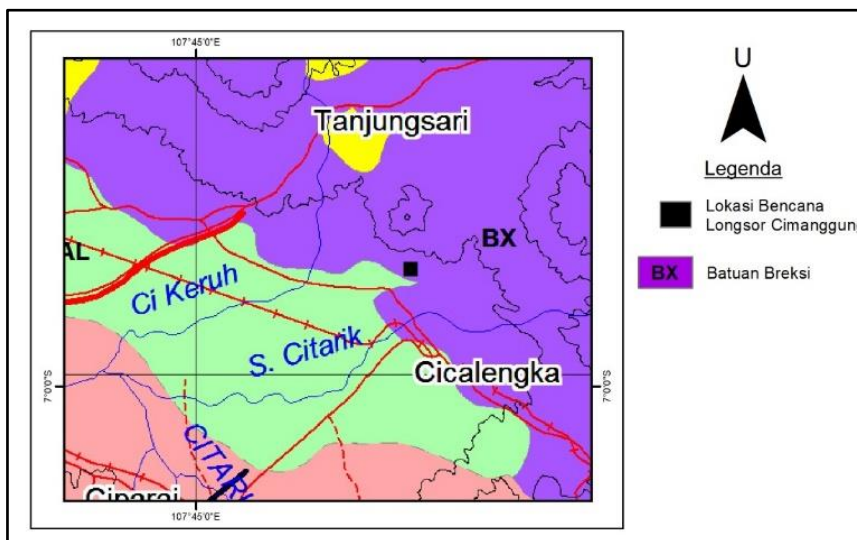
Figure 1. Landslide affected locations on Regional of Engineering Geological Map of West Java with a 1:500.000 scale.

In the Regional of Engineering Geological Map of West Java published by the Geology Agency in 2013, landslide affected areas are categorized into the weathered of breccia rock geology characteristic. Regionally, this breccia group is formed from Holocene Volcanic Rocks (Qv), Mount Neogene (Tnv),

Early Miocene Sedimentary Rocks (Tlss), Pliocene Sedimentary Rocks (Tlvs), Late Miocene Volcanic Rocks (Tmvs), Late Eocene-Miocene Volcanic Rocks (Tmv), Volcanic Rocks Pliocene (Tpvs), Oligo-Miocene (Tomv) Volcanic Rocks, and Tertiary (Early Miocene) Sedimentary Rocks: Tlss, Tmvs, and Tmev.

The lithology exposed around the study area was in the form of generally lightly weathered volcanic breccia, blackish gray-brownish, grained sand-crust, angled-angled grains, andesite components, basalt and pumice, and volcanic glass, open packaging, sandy tuff base mass, solid, compact, hard. The weathering soil was generally thin (<1.00 m), in the form of clay-sandy clay, reddish-brown, soft-firm, medium-high plasticity, low soil permeability, 2.00-4.50 m thick, CH group.

The hazards caused by geological processes that may occur in this group are generally landslides (especially on open land), and the soil's swelling nature can cause cracks or collapse of buildings.

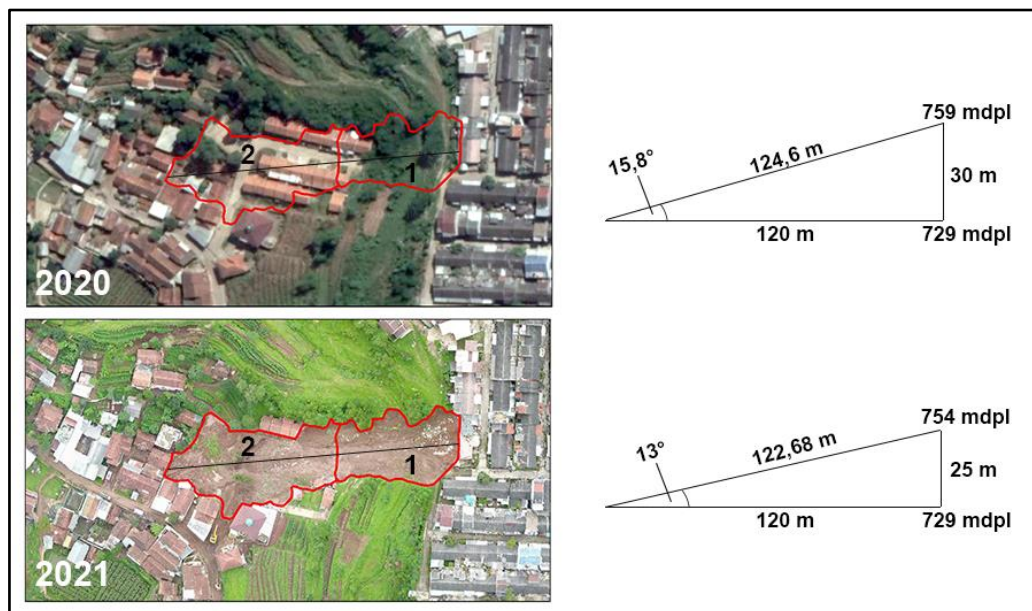
Figure 4. Results of aerial photo-taking using the UAV drone with slope measurements before and after the landslide.

As presented in Figure 4, landslide affected areas are clearly defined from the aerial photo-taking using the UAV drone, marked

by the red line. The east area (number 1) is the area affected by the first landslide due to a critical slope that failed to withstand a load

of rainwater filling the soil pores. Then a subsequent landslide occurred even more severely than the first landslide. Calculation of the flat area of the total landslide affected area shows that land covered 2267 m² in the first landslide and 1522 m² in the second landslide. Therefore, the total landslide area covering the earth's surface was 3.789 m².

The measured flat length ranges from 120 meters and 32 meters wide. A flat area is an area that is calculated on a 2D surface or a map without considering the slope of the slope. However, the slope of the slope has its discussion because the landslide incident will change the profile of the slope.

In Figure 3, there is a comparison of the slope profile between secondary elevation data before landslides (above) taken from the DEMNAS website with an accuracy of 8.25 meters and slope profiles after the landslide event taken from primary elevation data from aerial photo processing with an

accuracy of less than 1 meter. Calculation results demonstrate a difference in slope angle for 2.8 degrees. Of course, this figure becomes valid with the available data until the primary elevation data is found with the same accuracy so that the profile comparison becomes apple to apple.

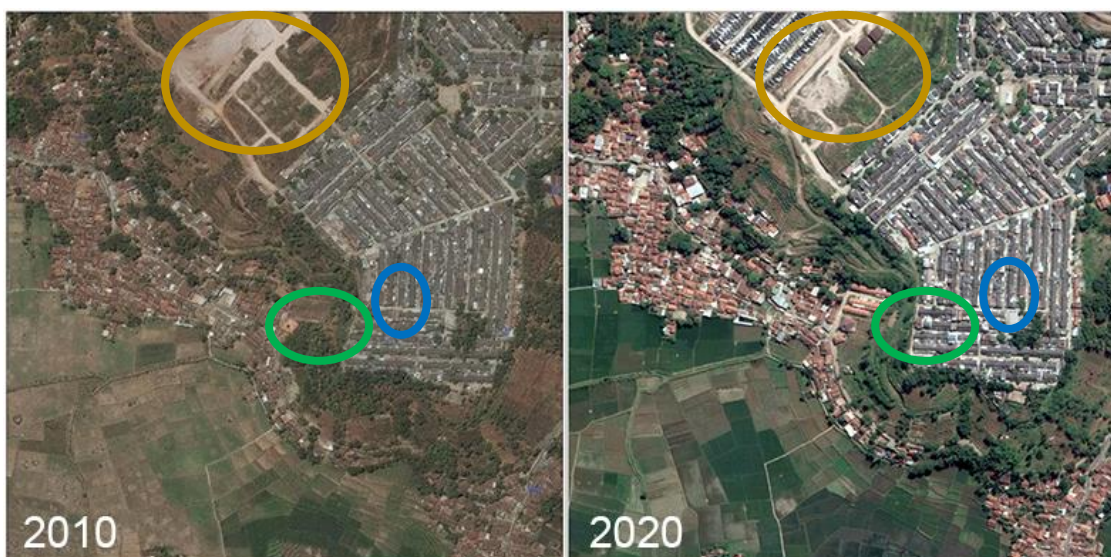
Figure 5. Local 10-year development comparison in landslide affected areas.

On the other hand, one of the human considerations in choosing a living place is the visual aspect or beautiful scenery. Therefore, some developers often develop development into hilly areas so that their products have a salable power. For example, in Cisarua Village, Cimanggung District, although several houses and even complexes had been built before 2010, the comparison above shows that property development in the area is continuing and massive. The green building was built in 2018, the blue

building was built in 2012, and the brown complex has developed since early 2019. The above observations were made with google earth imagery. Hills are rainwater catchment areas where there should be development restrictions to maintain downstream rainwater quality. Therefore, civil development should consider geomorphological and environmental geology aspects.

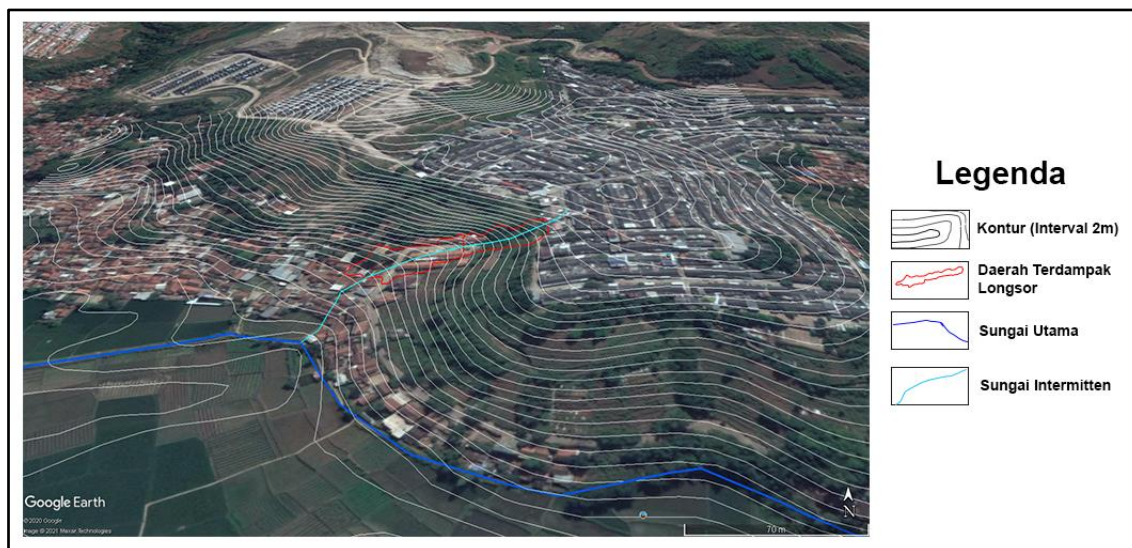
Figure 6. Morphology display of aerial photo image (Google Earth) of the landslide affected area (red) in local.

The geomorphological aspect of the landslide is also essential. When viewed from the contours produced by processed UAV drone data, the landslide affected area was right in the slope's valley area. Even with rainwater intensity that fell in early January, the valley turned into surface water flow or an intermittent river. The water flow from the top of the hill will descend into the main river below through the slope. In the field observations, the authors also found that water flowed down through the bush in the slope's direction. Therefore, with the existing conditions, there is an allegation that the landslide cause is the slopes losing their bearing force due to the accumulation of rainwater held back by the building bordered

by the main landslide that the slopes become heavier in weight and cannot withstand their weight. It continues a few moments later the soil pressure from the first landslide material will increase the load from the subsequent landslide area, so, naturally, subsequent landslides can occur because water that is held at the beginning of the building enters the ground under the second landslide area and causes the soil to lose its binding capacity. The last process that can be viewed from a morphological aspect is the massive land-use change that develops in the area, causing the flow volume of surface water to increase. It is undoubtedly dangerous for buildings that are elevated below it.

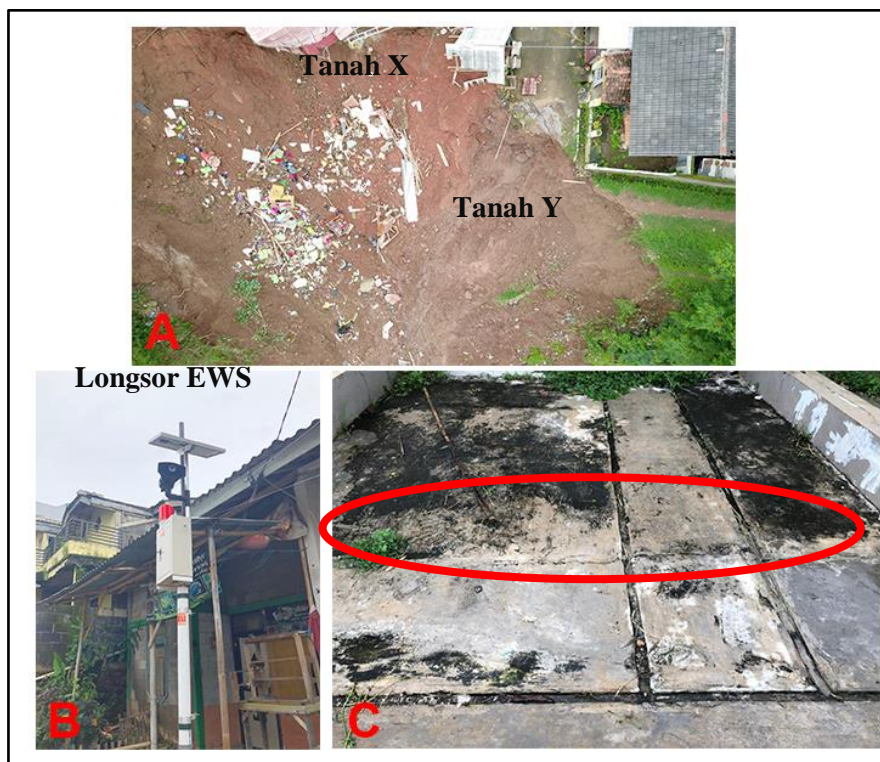
Figure 7. Field observation results from the technical geology aspect and risk mitigation of the affected area

Apart from morphological aspects, the engineering geology approach can also determine the suspected causes of landslides. When viewed from photo A in Figure 7, there was a significant difference in the soil's color and could be seen as

megascopic or massive. The color difference indicates two types of soil adjacent to one another. Indeed, natural soil will gradually darken because of the organic content in it. However, the anomaly found indicates that soil X was not natural land on the hill, but additional land buried to level the surface

aiming so that the land could be used for house construction. Soil Y was a natural soil resulting from weathering of rocks. The two soils were not held together by the cohesion

force because of their different physical properties. Therefore, differences in soil types are an indication of landslides.

Figure C shows cracks along with the building not affected by landslides around the landslide crown. Cracks or fractures indicate the direction and type of landslide. This evidence shows that landslides can occur in the slope direction or the area of the slope segment of the hills. Even though it is only a fracture, the area is still vulnerable for some time since the landslide occurred. Therefore, mitigation measures must be implemented quickly to minimize further casualties, both mental and material, from areas that are potentially affected by further landslides. One form of mitigation tool is seen in part B of figure 7, i.e., the Landslide Early Warning System (LEWS) prepared by the Agency for the Assessment and Application of Technology. This tool's mechanism is quite simple, the main pole with solar panel components and transistors will translate the movement of the two iron stakes connected to the rope so that if one of the iron pins moves, the siren will sound. The sound of sirens indicates that movements remain present from the ground surface, and the surrounding area still has potentials for further landslides.
