## EFFECT OF BEDDING PLANES ON SLOPE STABILITY IN COAL OPEN MINE PT. PAMAPERSADA NUSANTARA DISTRICT ASMI, CENTRAL KALIMANTAN

FAISAL AKBAR<sup>1</sup>, IRVAN SOPHIAN<sup>2</sup>, DICKY MUSLIM<sup>2</sup> and SAHALA MANULLANG<sup>3</sup>

<sup>3</sup>Engineering Departement, PT. Pamapersada Nusantara

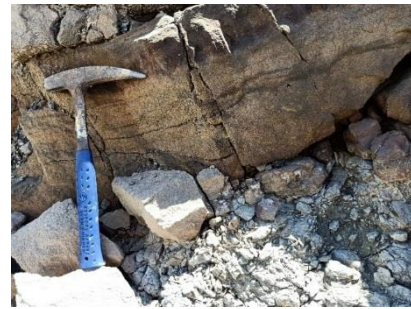
Figure 2. Close-up of Sandstone.

Sandstones are fresh gray in color, weathered brownish gray, fine - coarse sand grain size, good sorting, matrix supported, hard.

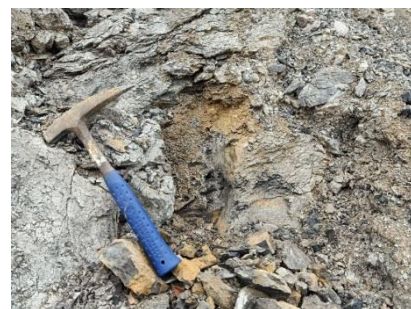
Figure 3. Close-up of Claystone.

Claystone is fresh colored blackish gray, weathered brownish gray, the size of the clay grains, soft to brittle.

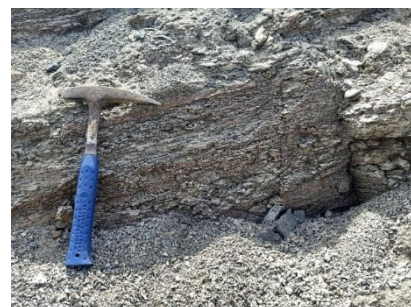
Figure 4. Close-up of Siltstone.

Siltstone is fresh gray in color, weathered whitish gray, silt grain size, good sorting, matrix supported, brittle.

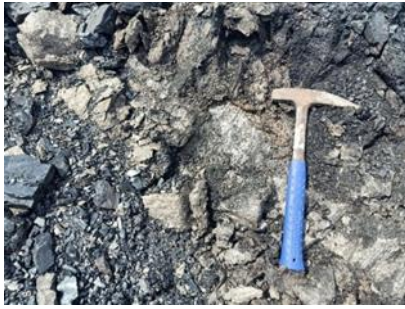
Figure 5. Close-up of Carbonaceous claystone.

Carbonaceous claystone is fresh blackish gray, weathered brown, clay grain size, carbonate, contains organic material, soft to brittle.

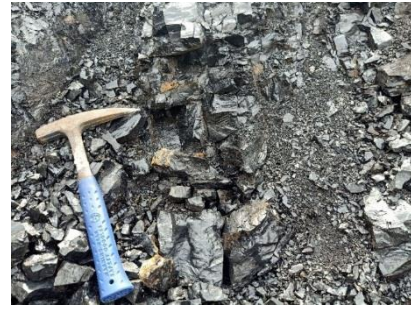
Figure 6. Close-up of Coal.

Coal is black in color with a slightly brilliant to brilliant luster (60% - 90%), black scratch, hard, strong resistance to blows, irregular fractions, good sorting, impurities in the form of amber, sandstones, and siltstone.

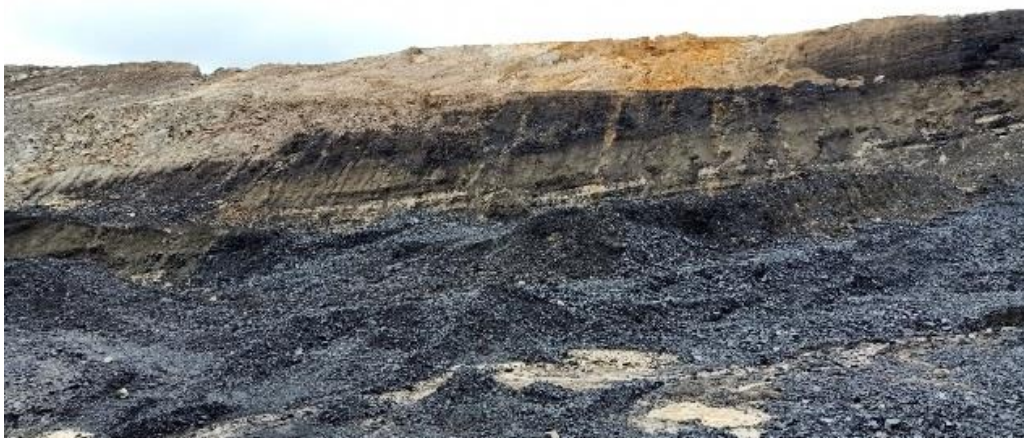
Figure 7. Appearance of Bedding Planes

The research slope is composed of sedimentary rock so that it has a layered appearance. The bedding planes can act as a discontinuity that triggers slope instability.

The identification of these bedding planes produces the following strike/dip values :

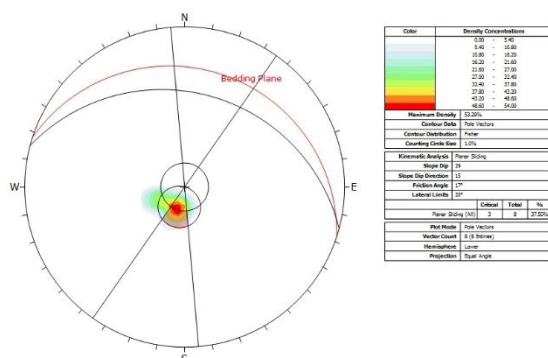
Figure 8. Kinematic Analysis Processing Results

Data processing for kinematic analysis using the Dips 6.0 application. Obtained percentage probability of landslide from the slope by entering the value of bedding plane strike dip, friction angle, slope dip, and slope dip direction. The following is the result of the kinematic analysis.

Based on the results of the stereonet projection, it shows that there is one pole pile from the measured bedding planes, while the average strike dip value of the bedding planes area is N 288 ° E / 17 °. The strike dip value of the bedding planes is relatively in line with the strike face of the slope with a difference of 3 °, the dip value of the bedding planes is 17 ° which is smaller than the yearly design dip overall slope which has a value of 29 °. Therefore, it can be interpreted that there is a potential plane failure on this slope (Hoek and Bray, 1981) with the direction of the landslide relative to the north - northeast with a

landslide probability of 37.50% of the total 8 strike dip data in the bedding planes. The plane failure can be used as a reference in determining the yearly design and the form of landslides in slope stability analysis.

Based on the analysis, the slope of the research has a potential plane failure caused by the presence of the bedding planes which has a dip direction that is relatively in the same direction as the slope. This landslide has greater potential when there is tension crack on the slope surface and it is water-saturated. With the consideration of the results of this analysis, there are two recommendations to minimize the occurrence of plane failure, namely by assuming the overall slope with a dip value equal to that of the bedding planes dip, namely 17 ° or changing the slope design by redesigning the dip direction of the slope from N 15 ° E to N 354 ° E.
