POTENTIAL COLLAPSE BASED ON DISCONTINUITY PLANE IN THE ANDESITE QUARY OF MOUNT GEULIS, JATINANGOR DISTRICT, SUMEDANG REGENCY, WEST JAVA

ABSTRACT

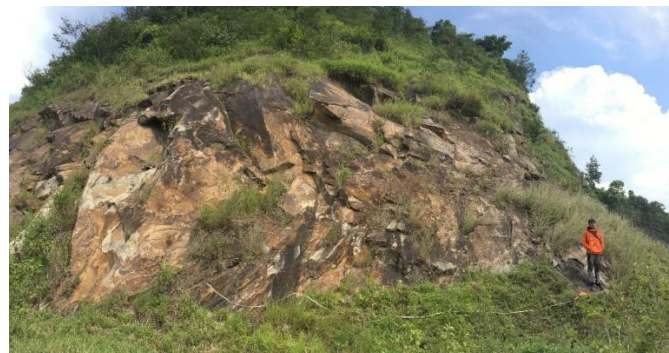
Figure 6. Outcrop photo of MT - 1 Segment

Based on megascopic observations, the rocks in this segment have a fresh gray-black color and weathered brownish color, mesocratic color index, have aphanitic granularity, have a massive structure, with a mafic mineral composition of 30% - 90%. This rock is composed of 70% plagioclase minerals, 5% k-feldspar, 18% amphibole and 8% opaque minerals, which means that the rocks in the MT - 1 segment is andesitic rock (Streckeisen, 1976)

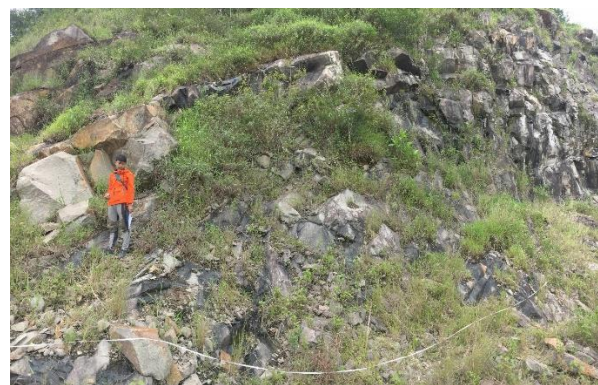
Figure 7. Outcrop photo of MT - 2 Segment

Based on megascopic observations, the rock in this segment has a fresh dark gray color and weathered brownish gray color, mesocratic color index, has aphanitic granularity, has a massive structure, with a mafic mineral composition of 30 - 90 %. This rock is composed of 65% plagioclase minerals, 15% k-feldspar, 15% amphibole, and 5% opaque minerals, which means that the rocks in the MT - 2 segment is andesitic rock (Streckeisen, 1976)

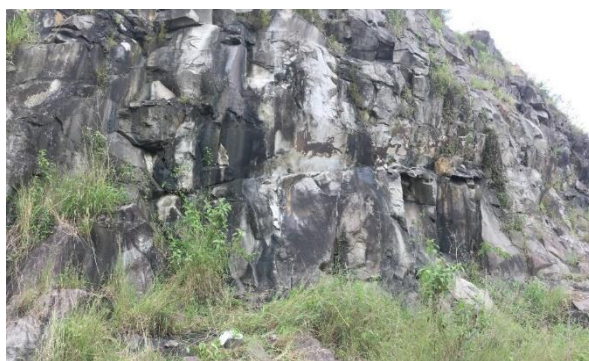
Figure 8. Outcrop Photo of MT - 3 Segment

Based on megascopic observations, rocks in this segment have a fresh gray color and weathered dark gray color, a mesocratic color index, have an aphanitic granularity, have a massive structure, with a mafic mineral composition of 30 - 90%. This rock is composed of 80% plagioclase minerals, 10% k-feldspar, 5% amphibole, and 5% opaque minerals, which means that the rocks in the MT – 3 segment is andesitic rock (Streckeisen, 1976).

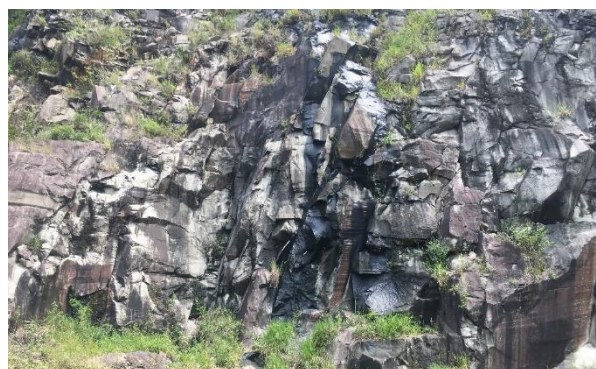
Figure 10. Outcrop Photo of MT - 5 Segment

Based on megascopic observations, the rocks in this segment have a fresh color of blackish gray and weathered color of brownish gray, mesocratic color index, have aphanitic granularity, have a massive structure, with a mafic mineral composition of 30 - 90 %. This rock is composed of 77% plagioclase minerals, 10% k-feldspar, 8% amphibole, and 5% opaque minerals, which means the rocks in the MT – 5 segment is andesitic rock (Streckeisen, 1976)

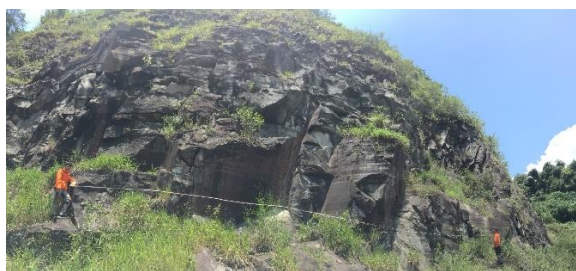
Figure 12. Outcrop of MT - 7 Segment

Based on megascopic observations, the rocks in this segment have a fresh color of light gray and weathered color of blackish gray, mesocratic color index, have aphanitic granularity, have a massive structure, with a mafic mineral composition of 30 - 90 %. This rock is composed of 63% plagioclase minerals, 10% k-feldspar, 12% amphibole, and 5% opaque minerals, which means that the rocks in the MT-7 segment is andesitic rock (Streckeisen, 1976).

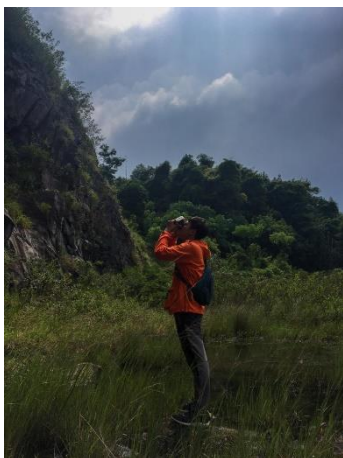
Figure 13. Slope Data Analysis

The slope angle value is obtained from the results of field measurements in each segment using a geological compass.

Segment Code	Slope(°)
MT - 1	78°
MT - 2	58°

MT - 3	81°
MT - 4	63°
MT - 5	85°
MT - 6	60°
MT - 7	86°

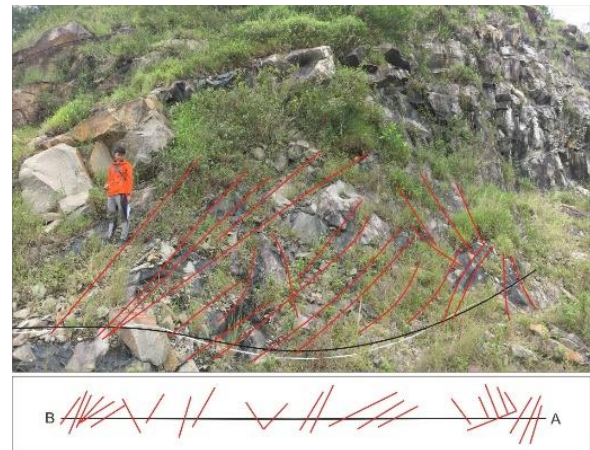
Figure 16. Outcrop Photo of the MT- 2 Segment

Based on the results of the stereonet projection, it shows that there are two pole peaks of the measured joint. From the top of the pole, the strike/dip value can be known by adding a plane to the top of the pole, so that it can be seen that the strike/dip value of the first plane is N278° E/69° and from the second plane is N307° E/29°, from these two planes it can be seen that there are two sets of joints that intersect each other. The two lines of intersection of the discontinuity planes penetrate the slope surface, have the direction of the line of intersection relatively close to the slope, and the slope angle value is greater than the angle line of intersection. Therefore, it can be interpreted that the MT-2 segment has a potential type of Wedge failure. Then based on a simulation using Dips 6.0 software, by adding parameters such as the lateral limit value, the internal friction angle value of 61°, and the slope angle of 58°. So, the percentage value of the possibility of landslides is 1.82%.

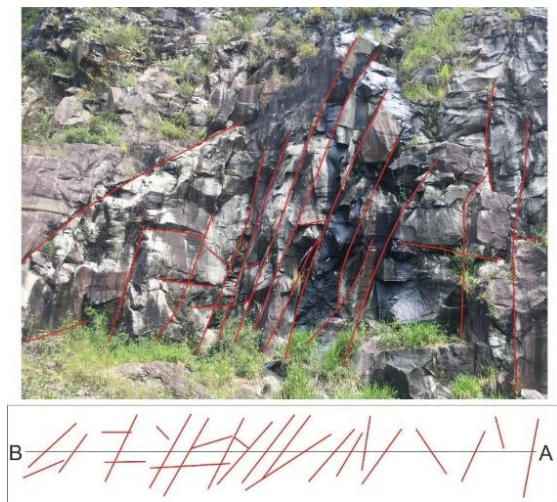
Figure 22. Outcrop Photos of the MT-5 Segment

Based on the results of the stereonet projection there are two pole peaks of the measured joints. From the top of the pole, the strike/dip value can be known by adding a plane to the top of the pole, so that the strike/dip value of the first field is N341°E/70° and the second plane is N249°E/81°. From these two planes we can see that there are two sets of intersecting joints. Having two lines of intersection of discontinuity planes that penetrate the slope surface, there is a direction from the line of intersection to the slope of the slope, the plunge from the line of intersection has a greater value than the internal friction angle. Therefore, it can be interpreted that the MT-5 segment has a potential type is Wedge failure. Then based on a simulation using Dips 6.0 software, by adding parameters such as the lateral limit value, the internal friction angle value of 60°, and the slope angle of 85°. So, the percentage value of the possibility of landslides is 3.91%.

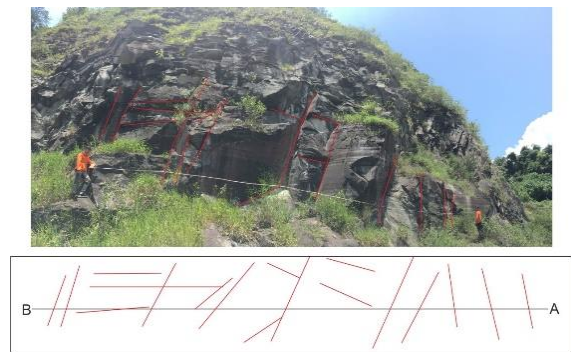
Figure 24. Photos of the MT - 6 Segment

Based on the results of the stereonet projection, there are two peaks joint pole from the measured projection. From the peak of the pole, the strike/dip value can be determined by adding a plane to the peak of the pole, so that the strike/dip value of plane the first is N340°E/72° and the second plane is N248°E/84°. From these two planes we can see that there are two sets of intersecting joints. The two lines of intersection of the discontinuity planes penetrate the slope surface, have the direction of the line of intersection approaching the slope of the slope, and the value of the plunge line of intersection is greater than the internal friction angle. Therefore, it can be interpreted that the MT-6 segment has a potential type of Wedge failure. Then based on a simulation using Dips 6.0 software, by adding such as the lateral limit value, the internal friction angle value of 60°, and the slope angle of 55°. So, the percentage value of the possibility of failure is 11.76%.

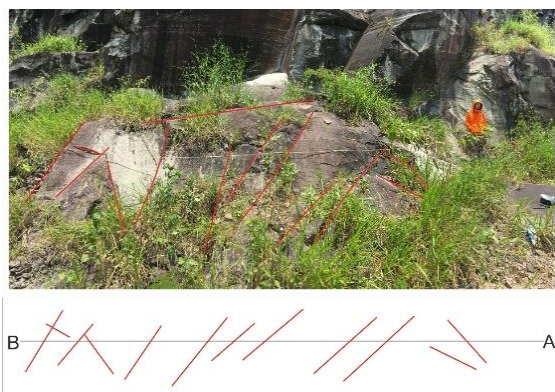
Figure 26. Outcrop Photos of the MT-7 Segment

Based on the stereonet projection there are two pole peaks from the measured joint projection. From the top of the pole, the strike/dip value can be known by adding a plane to the top of the pole, so that the strike/dip value of the first field is N133°E/21° and from the second plane is N82°E/17°. From these two planes we can see that there are two sets of intersecting joints. Has the direction of the line of intersection opposite to the direction of the face angle. Therefore, it can be interpreted that the type of landslide that may occur in the MT-7 segment is the type of Toppling failure. Then based on a simulation using Dips 6.0 software, by adding such as the lateral limit value, the internal friction angle value of 59°, and the slope angle of 86°. So, the percentage value of the possibility of landslides is 34.85%.
