Geotechnical Evaluation of Landslide in Nanggerang Village

Yohanes Tan¹, Zufaldi Zakaria¹, Ismawan¹, Irvan Sophian¹, and Nur khoirullah¹

¹Faculty of Geological Engineering, Universitas Padjadjaran

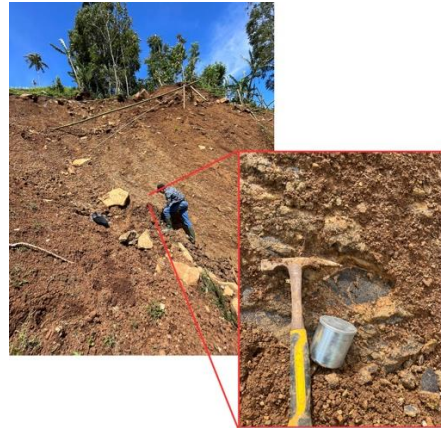
Figure 3. Distant and Close View of the Tuff Outcrop

The geological condition of the research location was determined through direct field observations and sample collection for further description. The observations and sample descriptions revealed the presence of tuff and andesite rocks. The tuff is believed to be the sliding surface from a previous landslide event.

The tuff outcrop forms the body of the landslide with an exposure height of 12.3 meters and a width of 24 meters. This rock has a fresh colour of yellowish-gray and a weathered colour of blackish-brown. The tuff grains are fine, rounded, with good sorting, poor grading, and a closed packing. It is soft, strongly weathered, and exhibits a layering structure with a strike and dip of N 122° E/36°. The dip of the tuff rock has the same direction as the slope inclination. If the rock layers have lower shear strength or weaknesses along the layers, this can facilitate the formation of shear planes aligned with the slope. Additionally, if there is water accumulation along the layers aligned with the slope, it can reduce the cohesion between rock particles and decrease the shear strength of the layer.

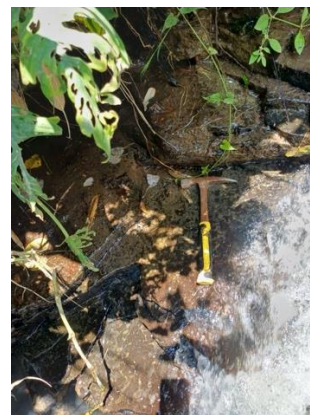
Figure 4. Close-Up View of the Andesite Outcrop

The andesite rock has a fresh yellowish-gray colour and a weathered brownish-yellow colour. It has a mesocratic colour index (30%-60%) and an aphanitic hypocrySTALLINE texture. It shows uniform equigranular crystal sizes with a predominance of hypidiomorphic granular texture and a sheeting joint structure.

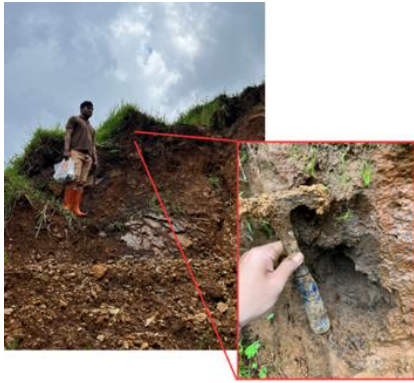
Figure 5. Distant and Close Views of the Silt (top soil) Outcrop in the Research Area

High Plasticity Silt (MH) forms the upper layer on the slope and surrounding areas. This soil is estimated to originate from the weathering of tuff. It has a reddish-brown to blackish-brown colour, with silt-sized particles and high plasticity. The soil has very high moisture content and high cohesive properties. According to the soil strength classification ISRM (1978), this soil ranges from S1 (very soft clay) to S3 (firm clay), characterized by the soil being compressible by a few inches with the thumb under slight pressure. The degree of weathering of this soil falls within the completely weathered zone (CWZ) up to the topsoil.

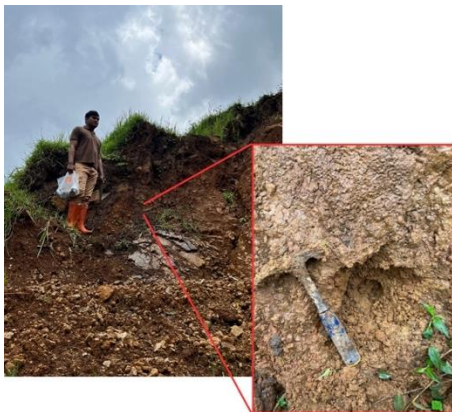
Figure 6. Distant and Close Views of the Silt (CWZ) Outcrop in the Research Area

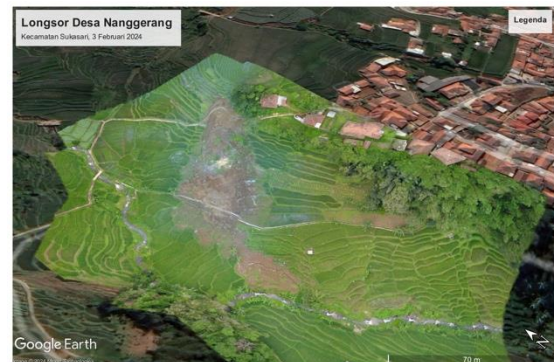
Figure 8. Satellite Imagery of the Research Area After Landslide

Before the landslide, the slope had a geometry consisting of 18 terraces with an average width of 2.45 meters, an average height of 1.52 meters, and an overall slope inclination of 32°. After the landslide, the slide scar formed has dimensions of 12 meters in length, 21 meters in width, and 16 meters in height, with an overall slope inclination of 34°.

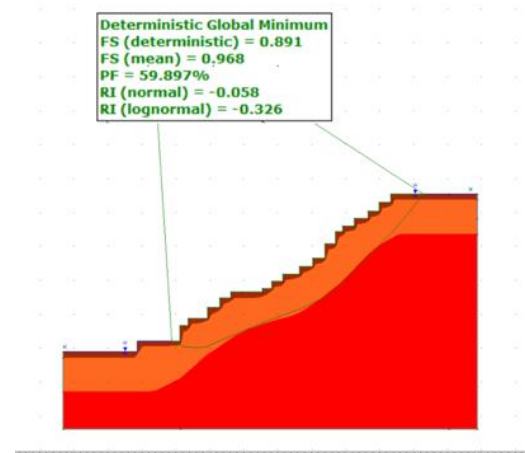
Figure 10. Simulation results of slope stability for cross-section A-A

This analysis focuses on the stability of slope cross-section A-A" before the occurrence of a landslide. The groundwater table condition on this slope is fully saturated because the entire slope is used as agricultural land. Data from the BMKG also shows that in February 2024, the research area had rainfall exceeding 500 mm (BMKG, 2024), categorized as very high rainfall. The slope geometry used is derived from direct measurements of the slope adjacent to a previous landslide. Each terrace has a slope of 90° because the terraces were created by farmers as planting media. The calculation uses the Morgenstern-Price limit equilibrium method with 1000 iterations to ensure accuracy and reliability.

The analysis was conducted with the groundwater table at a level parallel to the surface (fully saturated) without incorporating a seismic factor. The exclusion of seismic factors is due to the absence of earthquake events at the time of the landslide. The calculation results show a deterministic factor of safety (FK) value of 0.891, an average FK value of 0.968, and a probability of landslide (PK) of 58.897%. According to the recommendations for slope safety factor values from PUPR (2005) regarding slope failure handling engineering in residual soil and rock, the slope in cross-section A-A" is declared unstable. This conclusion is validated by the occurrence of an actual landslide, confirming the accuracy and reliability of the analysis.

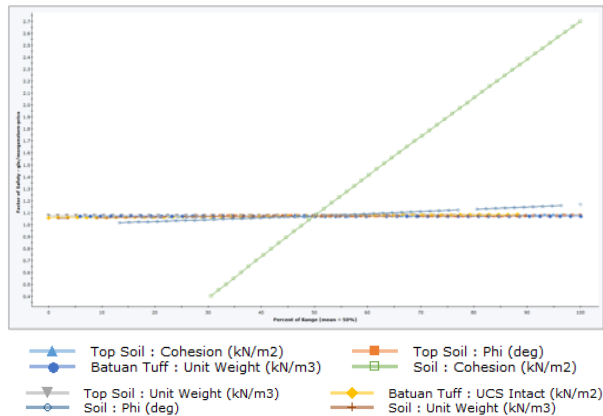
Figure 11. Sensitivity Plot Graph of Material Properties for Each Slope Material

Sensitivity analysis is a feature of the Slide 2 software. This feature provides information about which material properties most significantly affect slope stability calculations and the probability of failure. The analysis is conducted by plotting the material properties to obtain the equations for each variable. Variables with high sensitivity will show distinct graphs compared to others. The material properties used in the sensitivity analysis include the internal friction angle (ϕ), cohesion (c), and the unit weight of the topsoil layer, soil layer (CWZ), and tuff rock. The results of the sensitivity analysis for each layer are shown in Figure 9. From the sensitivity analysis plotting, it is observed that the cohesion parameter of the soil layer (CWZ) has a much steeper graph compared to other parameters, indicating that changes in soil cohesion have a significant impact on the factor of safety for a slope. Therefore, it is concluded that the cohesion parameter of the soil layer (CWZ) is more sensitive compared to other parameters.
