## CONTROL OF GEOLOGICAL STRUCTURE ON THE SPRINGS DISTRIBUTION AND THEIR PHYSICAL PROPERTIES. CASE STUDY: SOUTHERN SLOPE OF MT. LAMPOBATTANG, SOUTH SULAWESI

*The study area is located at Southern Slope of Mt. Lampobattang, South Sulawesi. According to Armstrong (2012), Sulawesi is controlled by a complex geological structure. This condition can affect the characteristics of subsurface groundwater (Ismawan, 2013) specifically on the distribution and physical properties of springs. So, this research is needed to do. The aim of this study is to know the effect of geological structure on the distribution and physical properties of springs in the study area. This research was conducted with a qualitative analysis method of field data which resulted by geological and hydrogeological mapping at the study area. Based on the analysis results, the study area is consisted of 7 rock units consist of tuff, breccia and lava. There are 6 faults that control the study area with SW-NE and SE-NW trend. The study area is divided into 3 fracture density zones, those are low fracture density ( $0-500\text{ M}^{-1}$ ), medium fracture density ( $500-950\text{ M}^{-1}$ ), and high fracture density ( $95

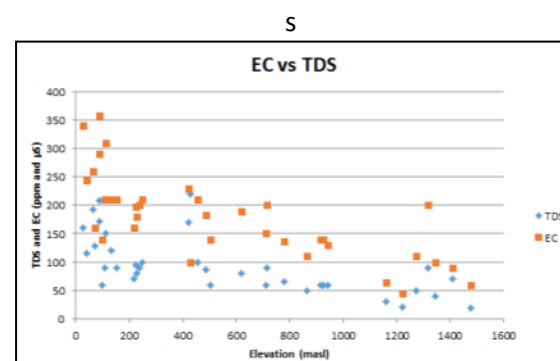
**Figure 4.** Graph of relatively low TDS dan EC values that shows springs are controlled by geological structures

Based on the analysis of its physical properties, the springs of the study area have relatively low EC and TDS values. Springs TDS values have a vulnerable value of 0-193 ppm and EC values 0-357  $\mu$ S (Figure 4). This is because springs are controlled by geological structures.

Fault can cause the regional or deep groundwater flow out to the surface. Regional or deep groundwater has low EC and TDS values because it does not interact much with various rocks. Therefore, the springs that are located along the fault have a low range of EC and TDS values (Ismawan, 2013).

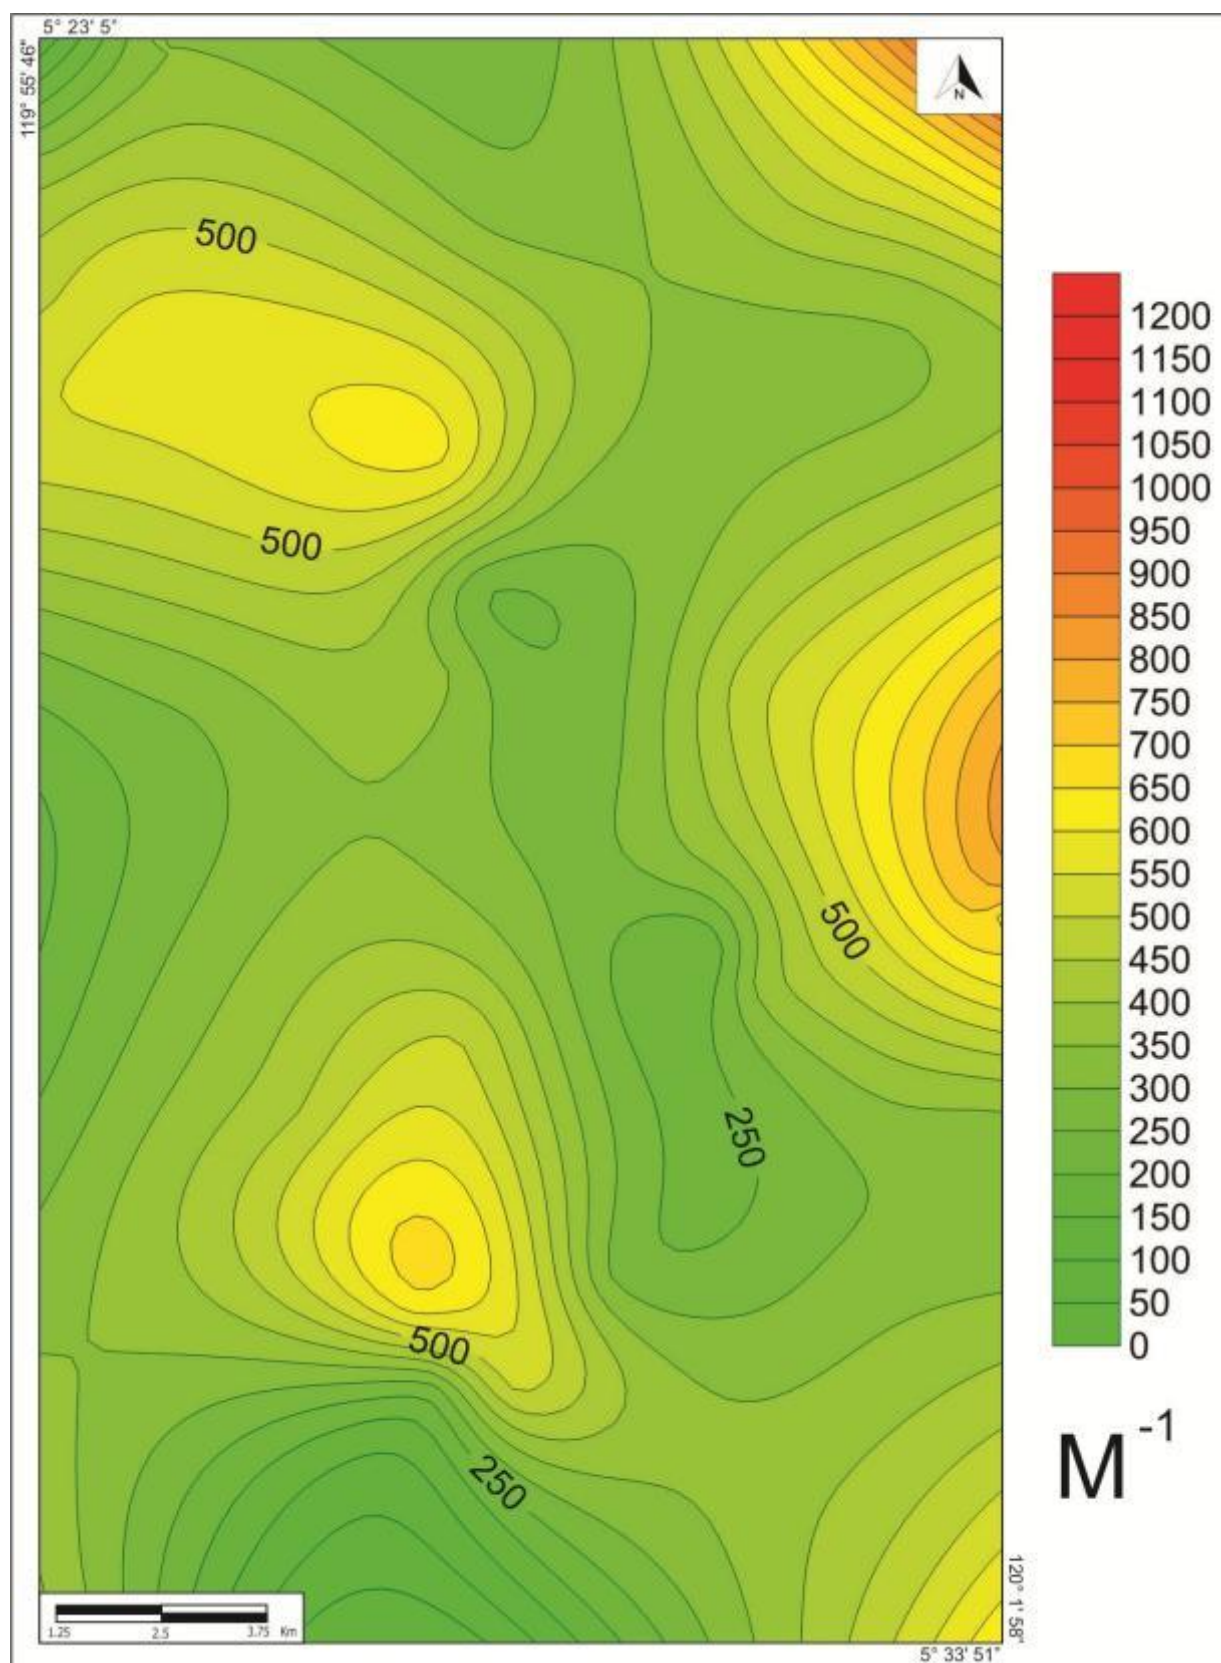
**Picture 7.** Fracture density of study area

According to the analysis of fracture density, the study area was divided into 3 zones, which are low fracture density (0-500 M<sup>-1</sup>), medium fracture density (500-950 M<sup>-1</sup>), and high fracture density (950-1200 M<sup>-1</sup>) (Figure 7 ). Low and medium fracture density spread throughout the study area, especially in the north to south. While the high fracture density, located in the southwest, east, and northwest of the study area.

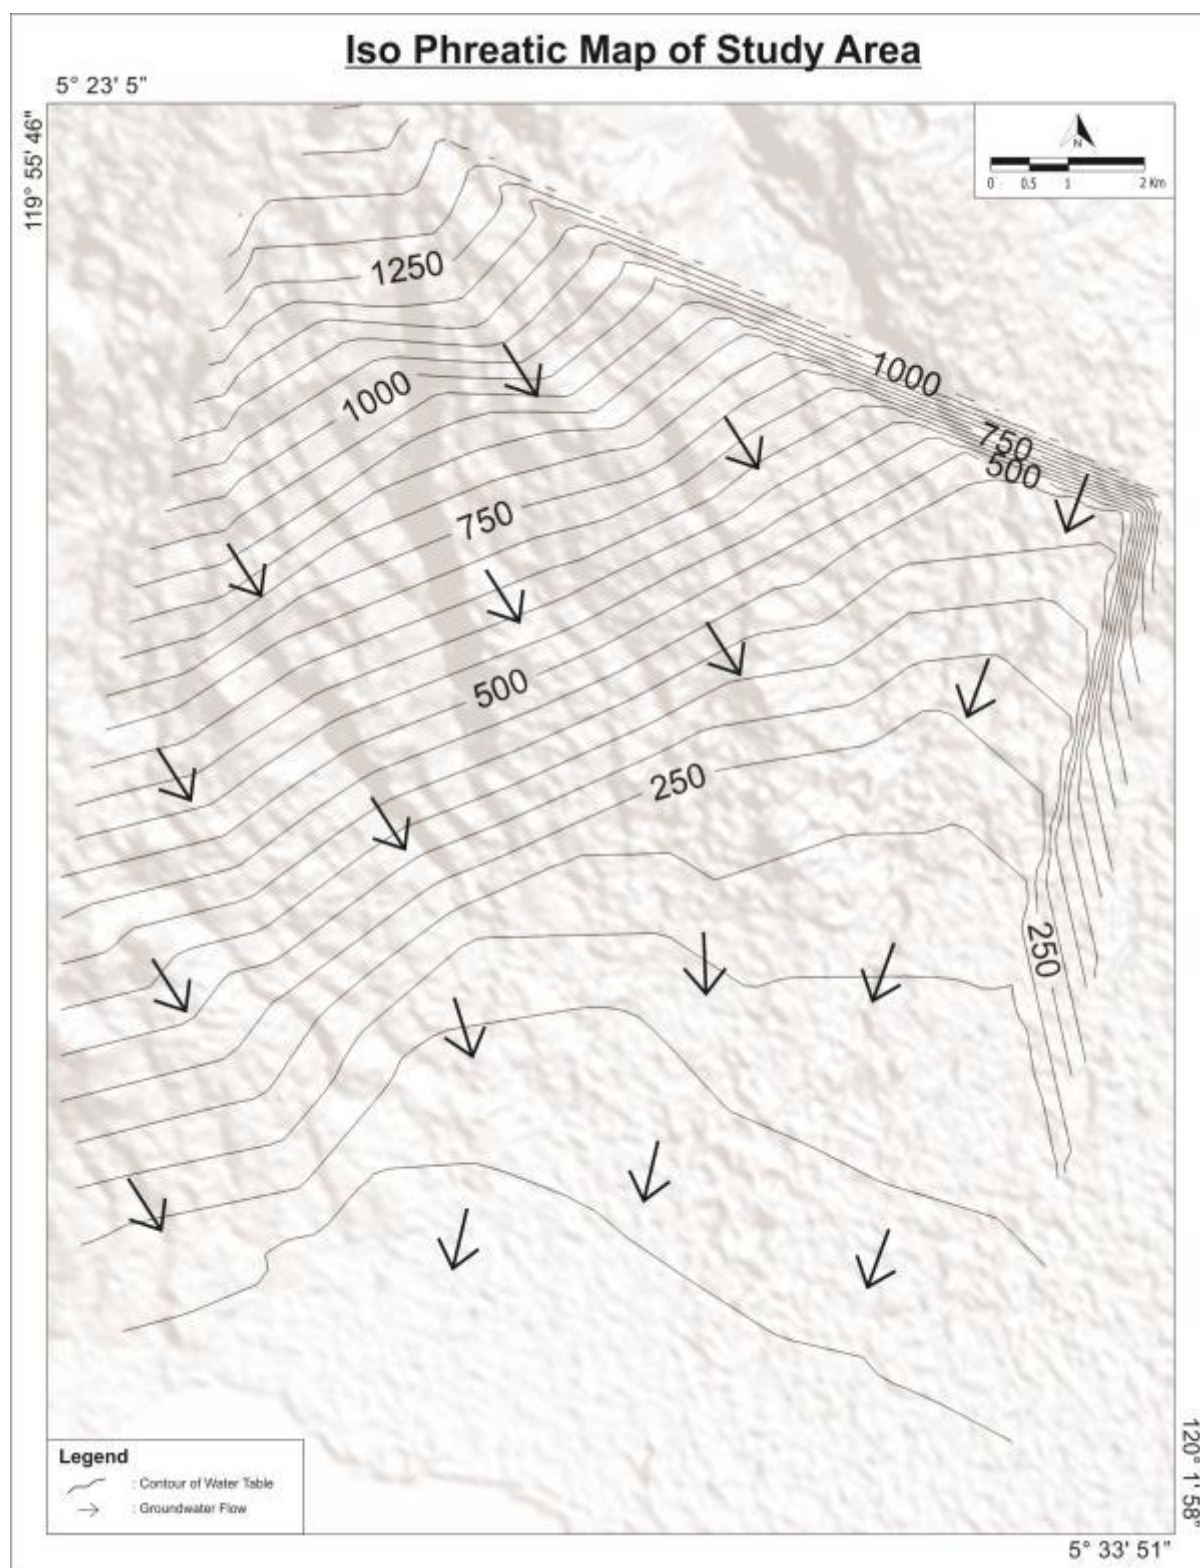
**Picture 10.** Iso Phreatic Map of Study Area

The groundwater flow is estimated flows from the northwest and northeast of the study area to the Flores Sea. This is indicated by an isophreatic map that describes the direction of groundwater flow in the study area (Figure 10).

Groundwater is estimated to flow in breccia and also lava which has a high fracture density. The source of the groundwater flow comes from Mt. Lampobatang and causes the occurrence of springs along the flow.
